The POWER of position

by Robert Kaplan
Predictive Maintenance Engineer
Florida Power & Light
St. Lucie Plant

Vibration levels were not the indicator of degraded turbine generator bearings at Florida Power & Light's St. Lucie Plant. Although the vibration diagnostics indicated that a problem was developing, vibration levels did not increase to unacceptable levels. Shaft position information, available through Bently Nevada proximity probes, provided the supporting information that convinced plant personnel to inspect the damaged bearings.

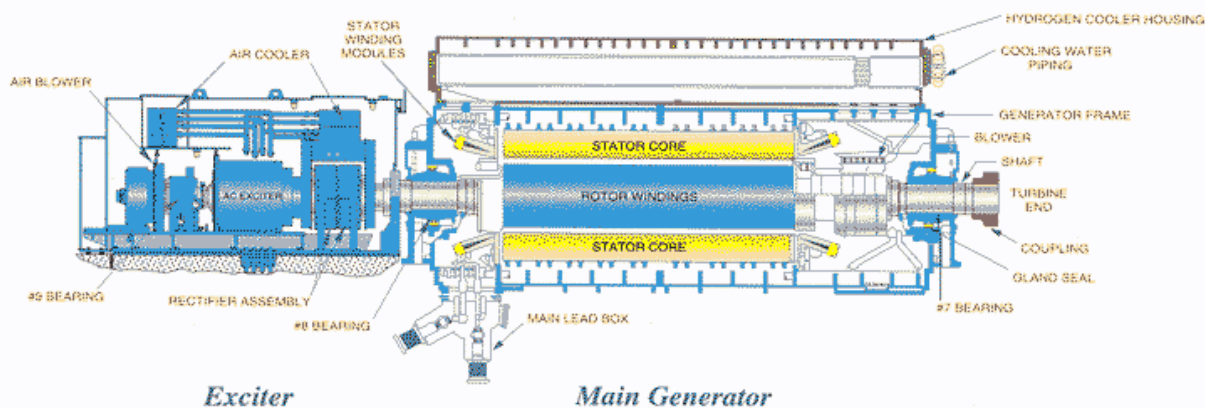
Figure 1

Bearings #7 and #8 support the generator rotor, and Bearings #8 and #9 support the exciter rotor. Bearing #9 also supports an overhung fan and permanent magnet generator (Figure 1). None of these bearings has an oil lift system.

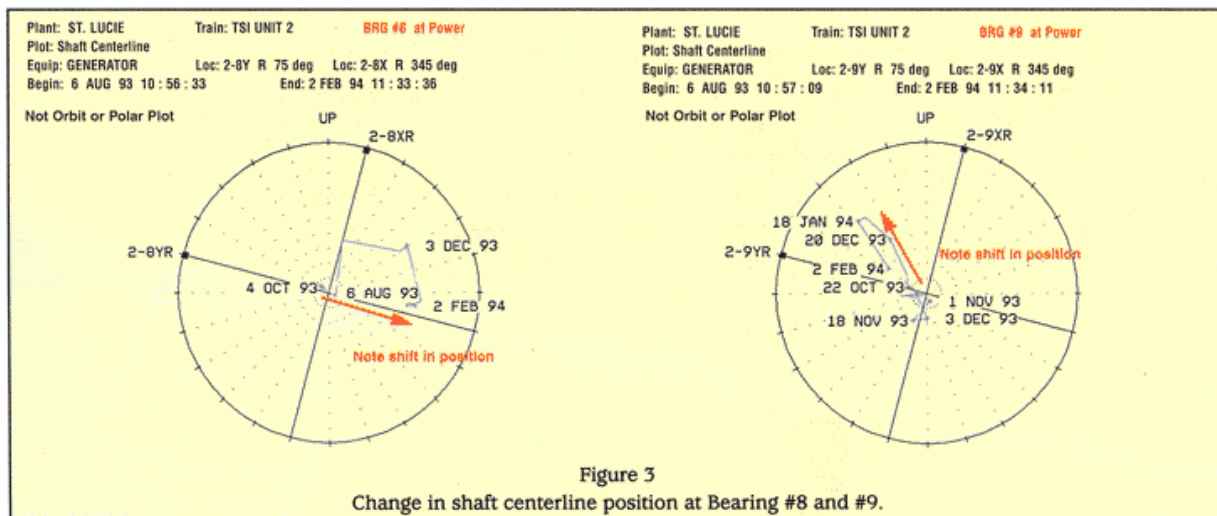
On November 2, Unit 2 was manually shut down for a short time to correct a temperature excursion. Analysis of vibration data routinely taken after restart identified some changes to the vibration signature of the exciter (Table 1 and Figure 2).

- 1) Bearing #7: The 1X relative vibration patterns did not significantly change.
- 2) Bearing #8: The 1X relative vibration levels increased 1.9 mils to 2.6 mil pp and stabilized at this increased level. The 1X phase angles didn't significantly change. *More significantly, the shaft position had immediately shifted 6 mils horizontally.*
- 3) Bearing #9: The 1X relative vibration levels increased by 1.2 mil pp over the next 15 weeks to 3.4 mil pp.

The 1X phase angle of the Y and X vibration signals increased 31 degrees and 108 degrees, respectively. *The shaft position also shifted 6 mils, but in the opposite direction from Bearing #8, over the next several weeks (Figure 3).*
